SUBSIDENCE CRACKS IN ALLUVIUM NEAR  
CASA GRANDE, ARIZONA

E. F. Pashley, Jr.

U. S. Geological Survey, Tucson, Arizona

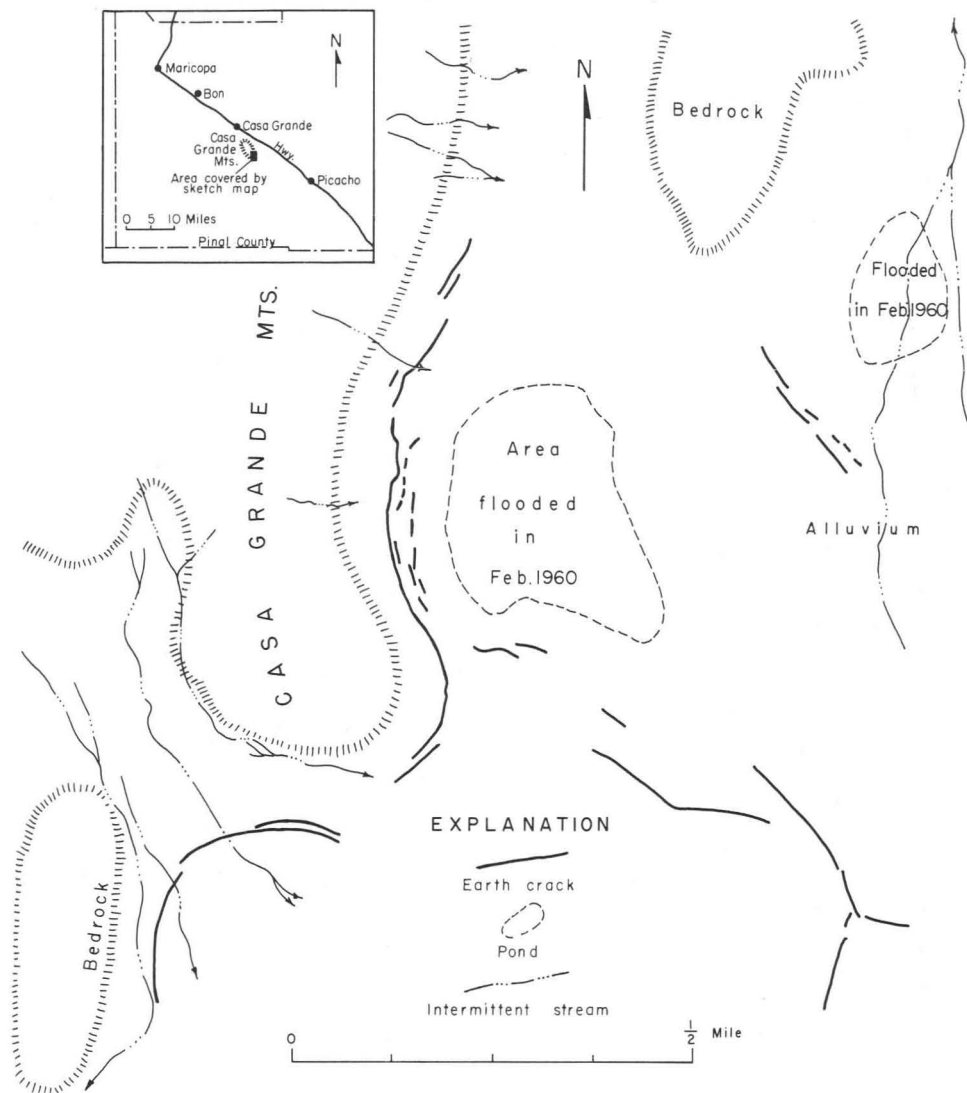
Figure 1.—Sketch map showing pattern of earth cracks at the southeast corner of the Casa Grande Mountains, February 1960.

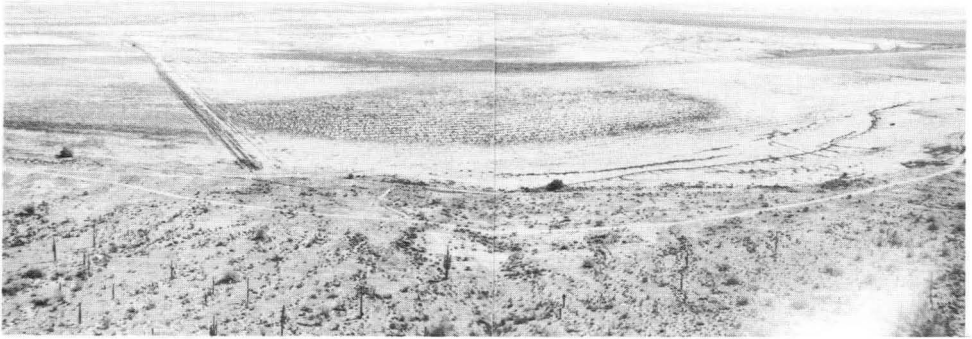
Figure 2. -- View looking southeast from the Casa Grande Mountains across large pond in center of Figure 1, showing ponded rainwater in center of furrowed field and earth cracks bordering the pond.

In the area adjacent to the Casa Grande Mountains the trend of the cracks parallel to the edges of the ponds and the edge of the mountains supports the idea that the earth cracks are the result of shallow subsidence caused by the ponding of rainwater. Also, the ponds themselves probably occupy subsidence depressions.

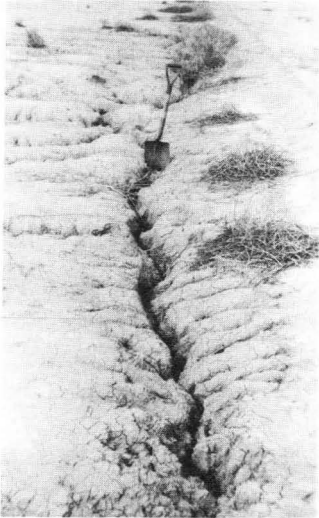
The longest zone of cracks, consisting of several long cracks and a number of parallel short cracks, is continuous for slightly more than half a mile. The cracks range in depth from a few inches to as much as 8 feet, and in width from several inches to about 3 feet (Figs. 3 and 4). The depth seems to vary inversely with the width; the deepest cracks were usually the narrowest. Also, the depth of individual cracks varies greatly along their courses, and is roughly proportional to the amount of slumping. Widening of the cracks seems to have resulted from the slumping from the sides and the slumped material partly fills or bridges the deep parts of the cracks. No cracks showed evidence of horizontal movement.

Figure 3. -- Typical earth crack, showing some modification by erosion but little slumping of sides.

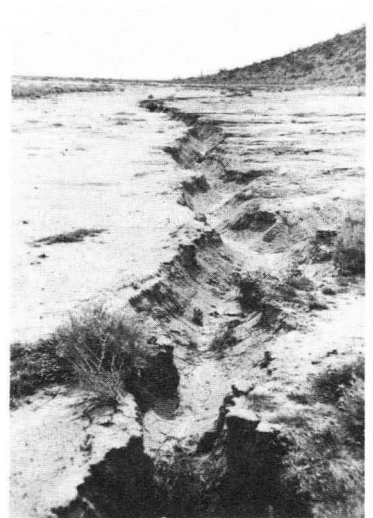
Figure 4. -- Earth crack which has become wider and shallower by slumping of the sides.

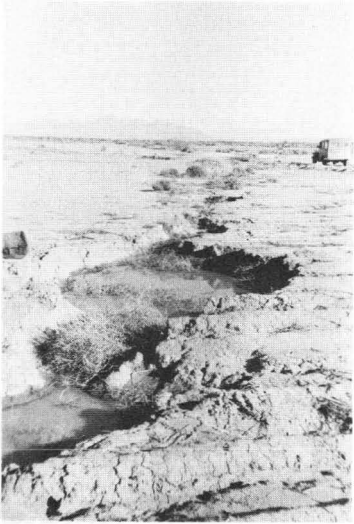
Figure 5. --Sinklike depression along an earth crack.

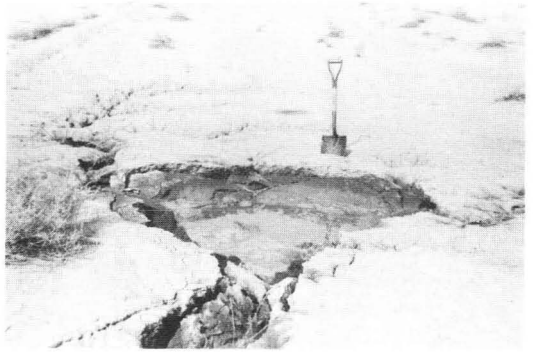
Figure 6. --Sinklike depression where three earth cracks meet.

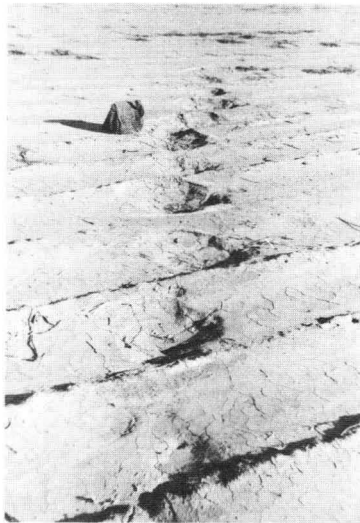
At one place, a line of small depressions as much as a foot in diameter continued the trace of a crack after the crack itself had died out. The aligned depressions suggest that the crack is present in the subsurface (Fig. 7).

Figure 7. --Circular depressions which continue the trace of an earth crack.
