FRONTIERS IN GEOLOGY AND ORE DEPOSITS OF ARIZONA AND THE SOUTHWEST

Arizona Geological Society and the University of Arizona 1986 Symposium

FIELD TRIP GUIDEBOOK # 12

Geologic Hazards of Tucson

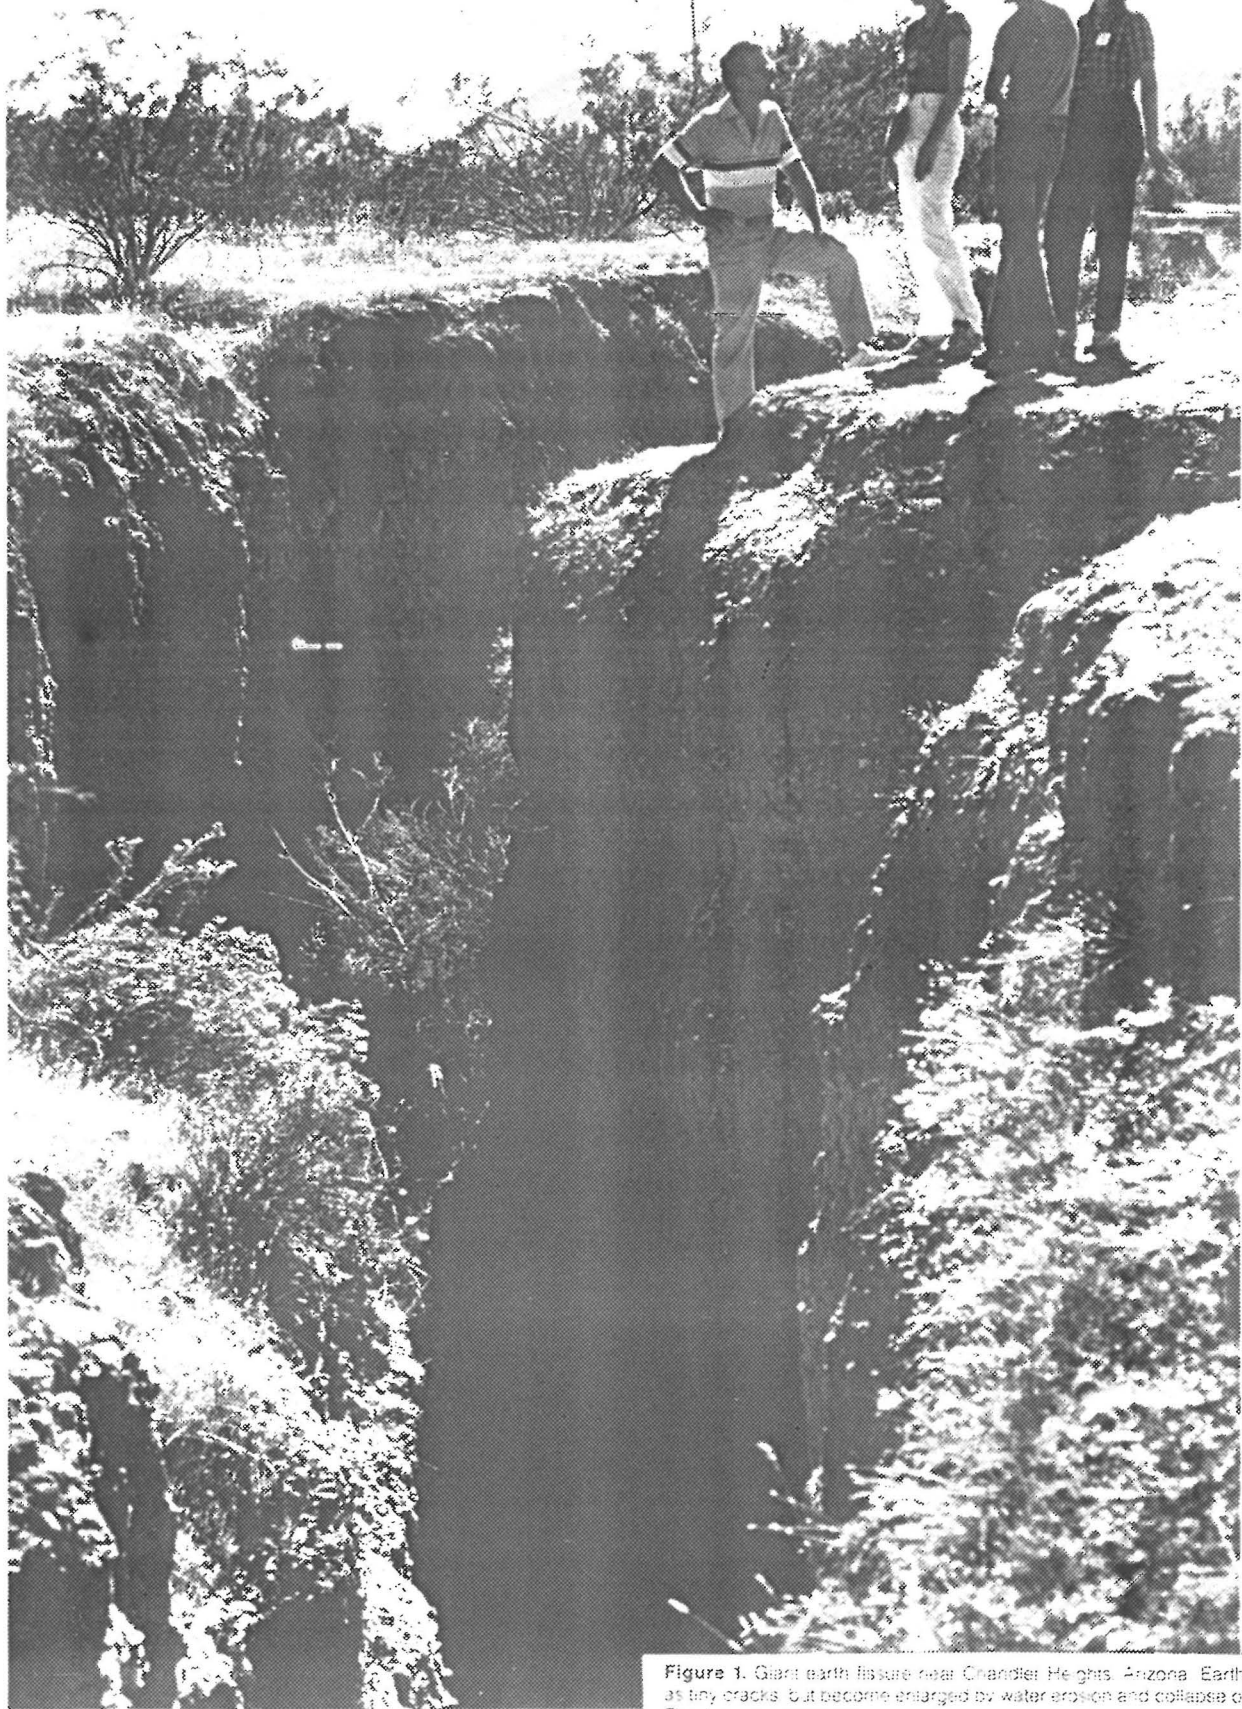
Figure 1. Giant earth fissure near Chandler Heights, Arizona. Earth fissures begin as tiny cracks, but become enlarged by water erosion and collapse of adjacent soils. This fissure is related to subsidence due to ground-water withdrawal. Photo taken on October 21, 1985 by Larry D. Fellows.

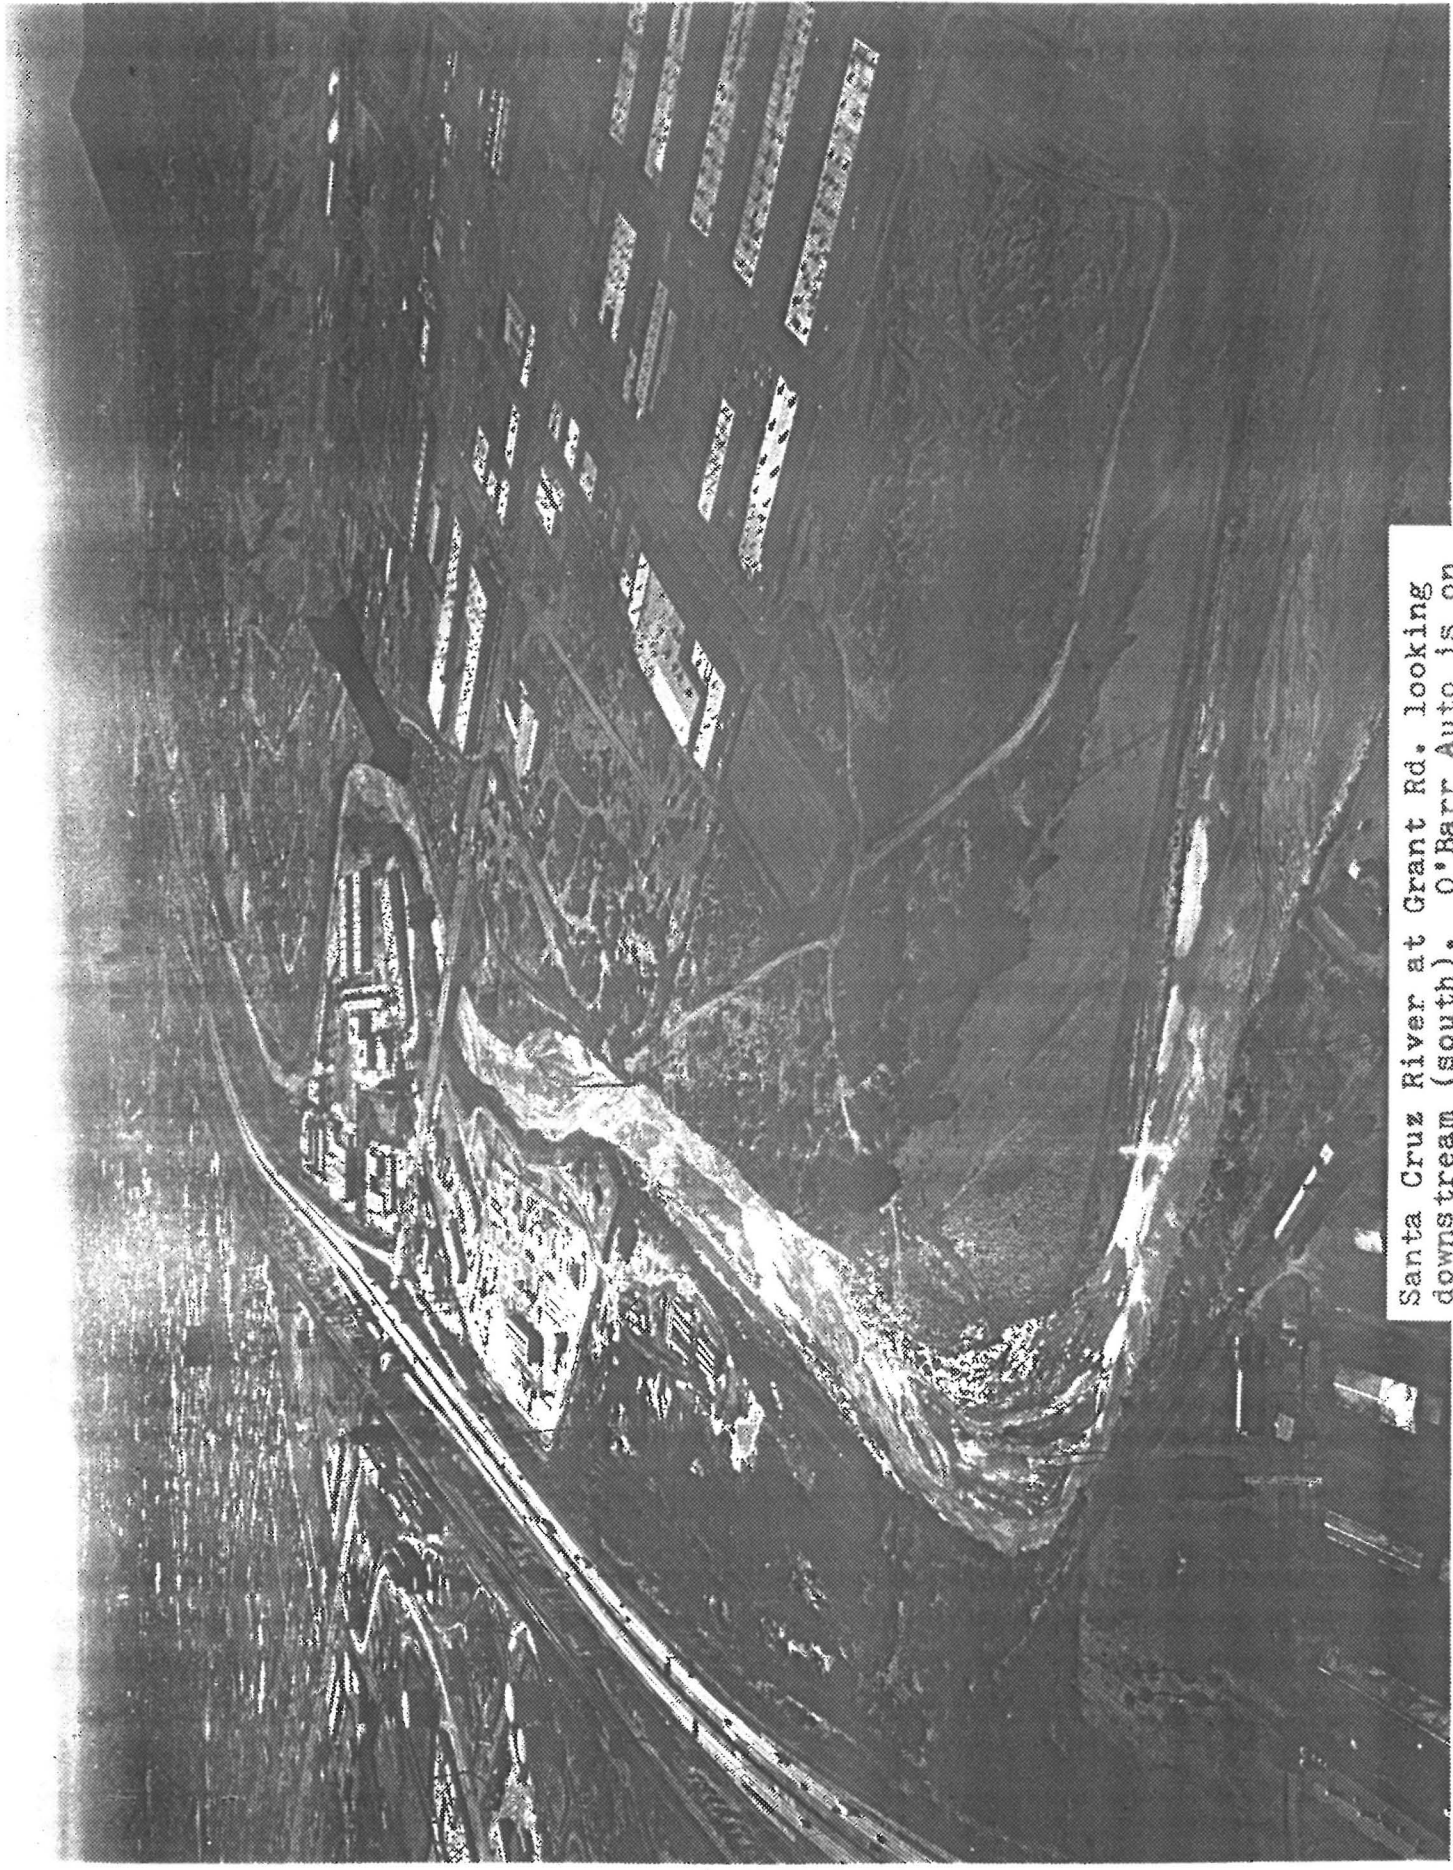
Santa Cruz River at Grant Rd. looking downstream (south). O'Barr Auto is on outside of meander bend.

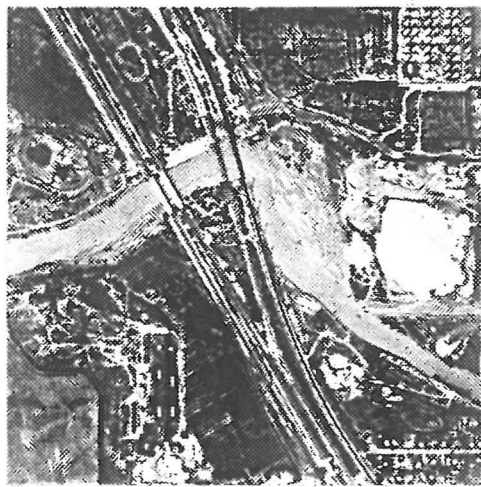
The I-10/S-P crossing of the Rillito River

1941

October 1978

January 1979

October 1983

Two separate winter flow events, recorded in March and December of 1978, produced the channel change seen in the accompanying photographs. The annual peak discharge record of Rillito Creek at Tucson is shown on the accompanying diagram. Two such separate winter flow events had never been recorded previously in Rillito Creek within a 9-month period, nor in Tanque Verde Creek and its watershed where the flow events originated. The March flow reduced the amount of easily entrained sediment within the stream channels, which increased the tendency of the December flow to erode their banks (Thomas Maddock, Jr., University of Arizona, written communication, 1980). Undercutting of the banks of Rillito Creek caused large blocks of land to slump into the channel, where they were disaggregated and swept downstream.

One result of this set of conditions was a shift in alignment of the Rillito Creek approach to the Southern Pacific Railroad Bridge east of Interstate 10. The bridge was constructed in 1925 perpendicular to the direction of flow in Rillito Creek. The channel remained in essentially the same position until the peak flow of December 18, 1978, when a large bend in the channel directly upstream of the bridge shifted to the west, removed approximately 50 acres of land, and damaged the northern abutment of the bridge (Laursen, 1979). As a result, the channel and bridge are no longer aligned. The river currently tends to flow northward parallel to and against the railroad embankment before attempting to turn approximately 90 degrees to the west and flow underneath the bridge. The bridge has since been reinforced. Stands of tires have been placed in the channel in an effort to redirect streamflow, and the banks have been rip-rapped in order to prevent further bank erosion. The approaches to several other bridges across Rillito Creek were damaged extensively by this flow event (Federal Emergency Management Agency, 1981).

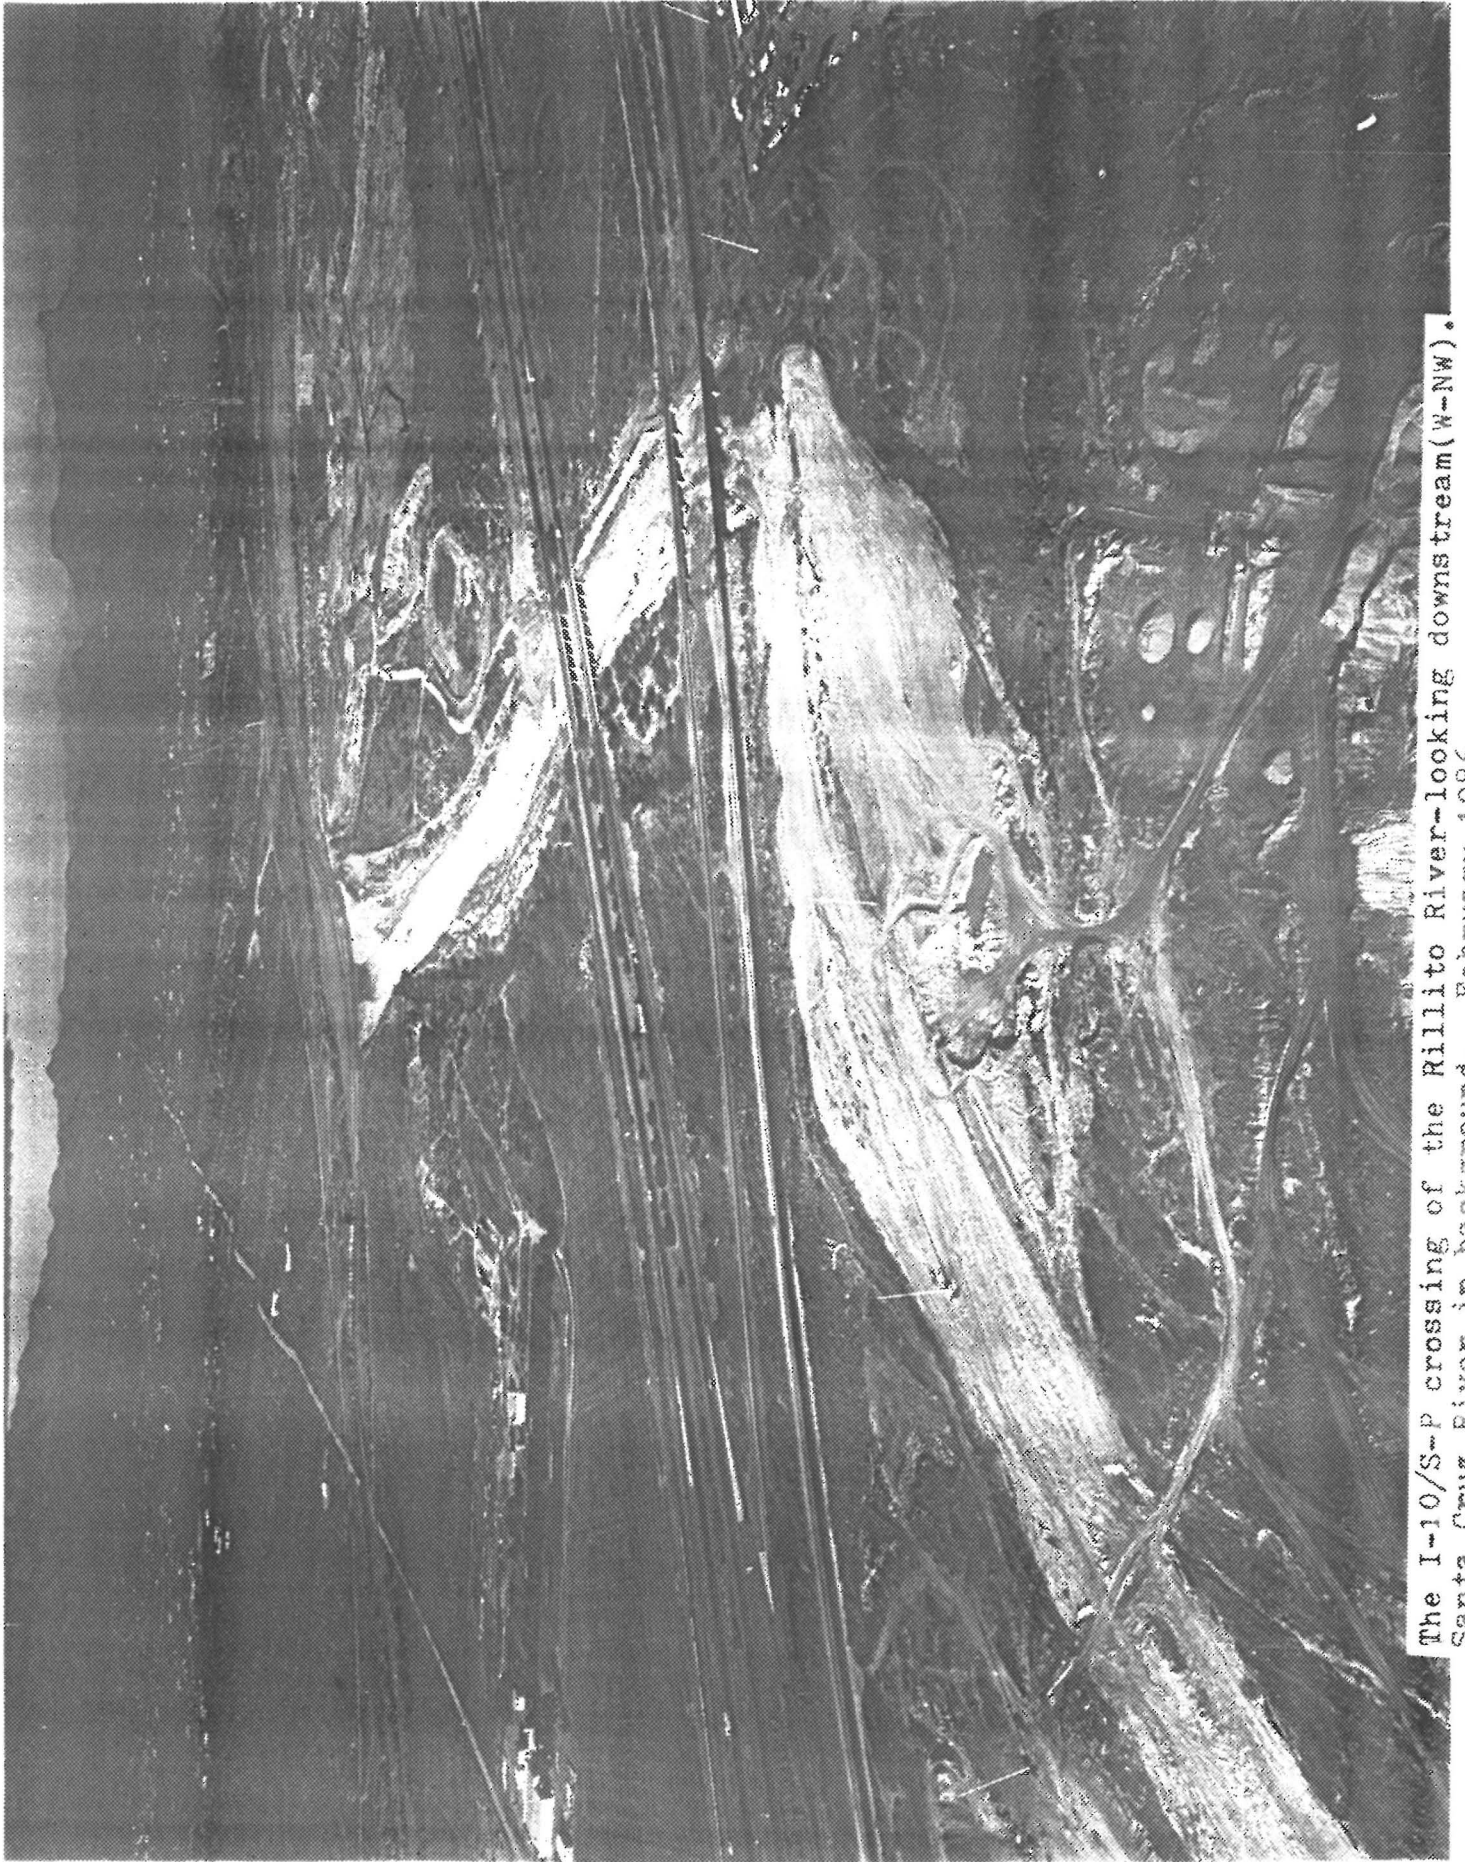
The I-10/S-P crossing of the Rillito River-looking downstream (W-NW).
Santa Cruz River in background. February 1986.

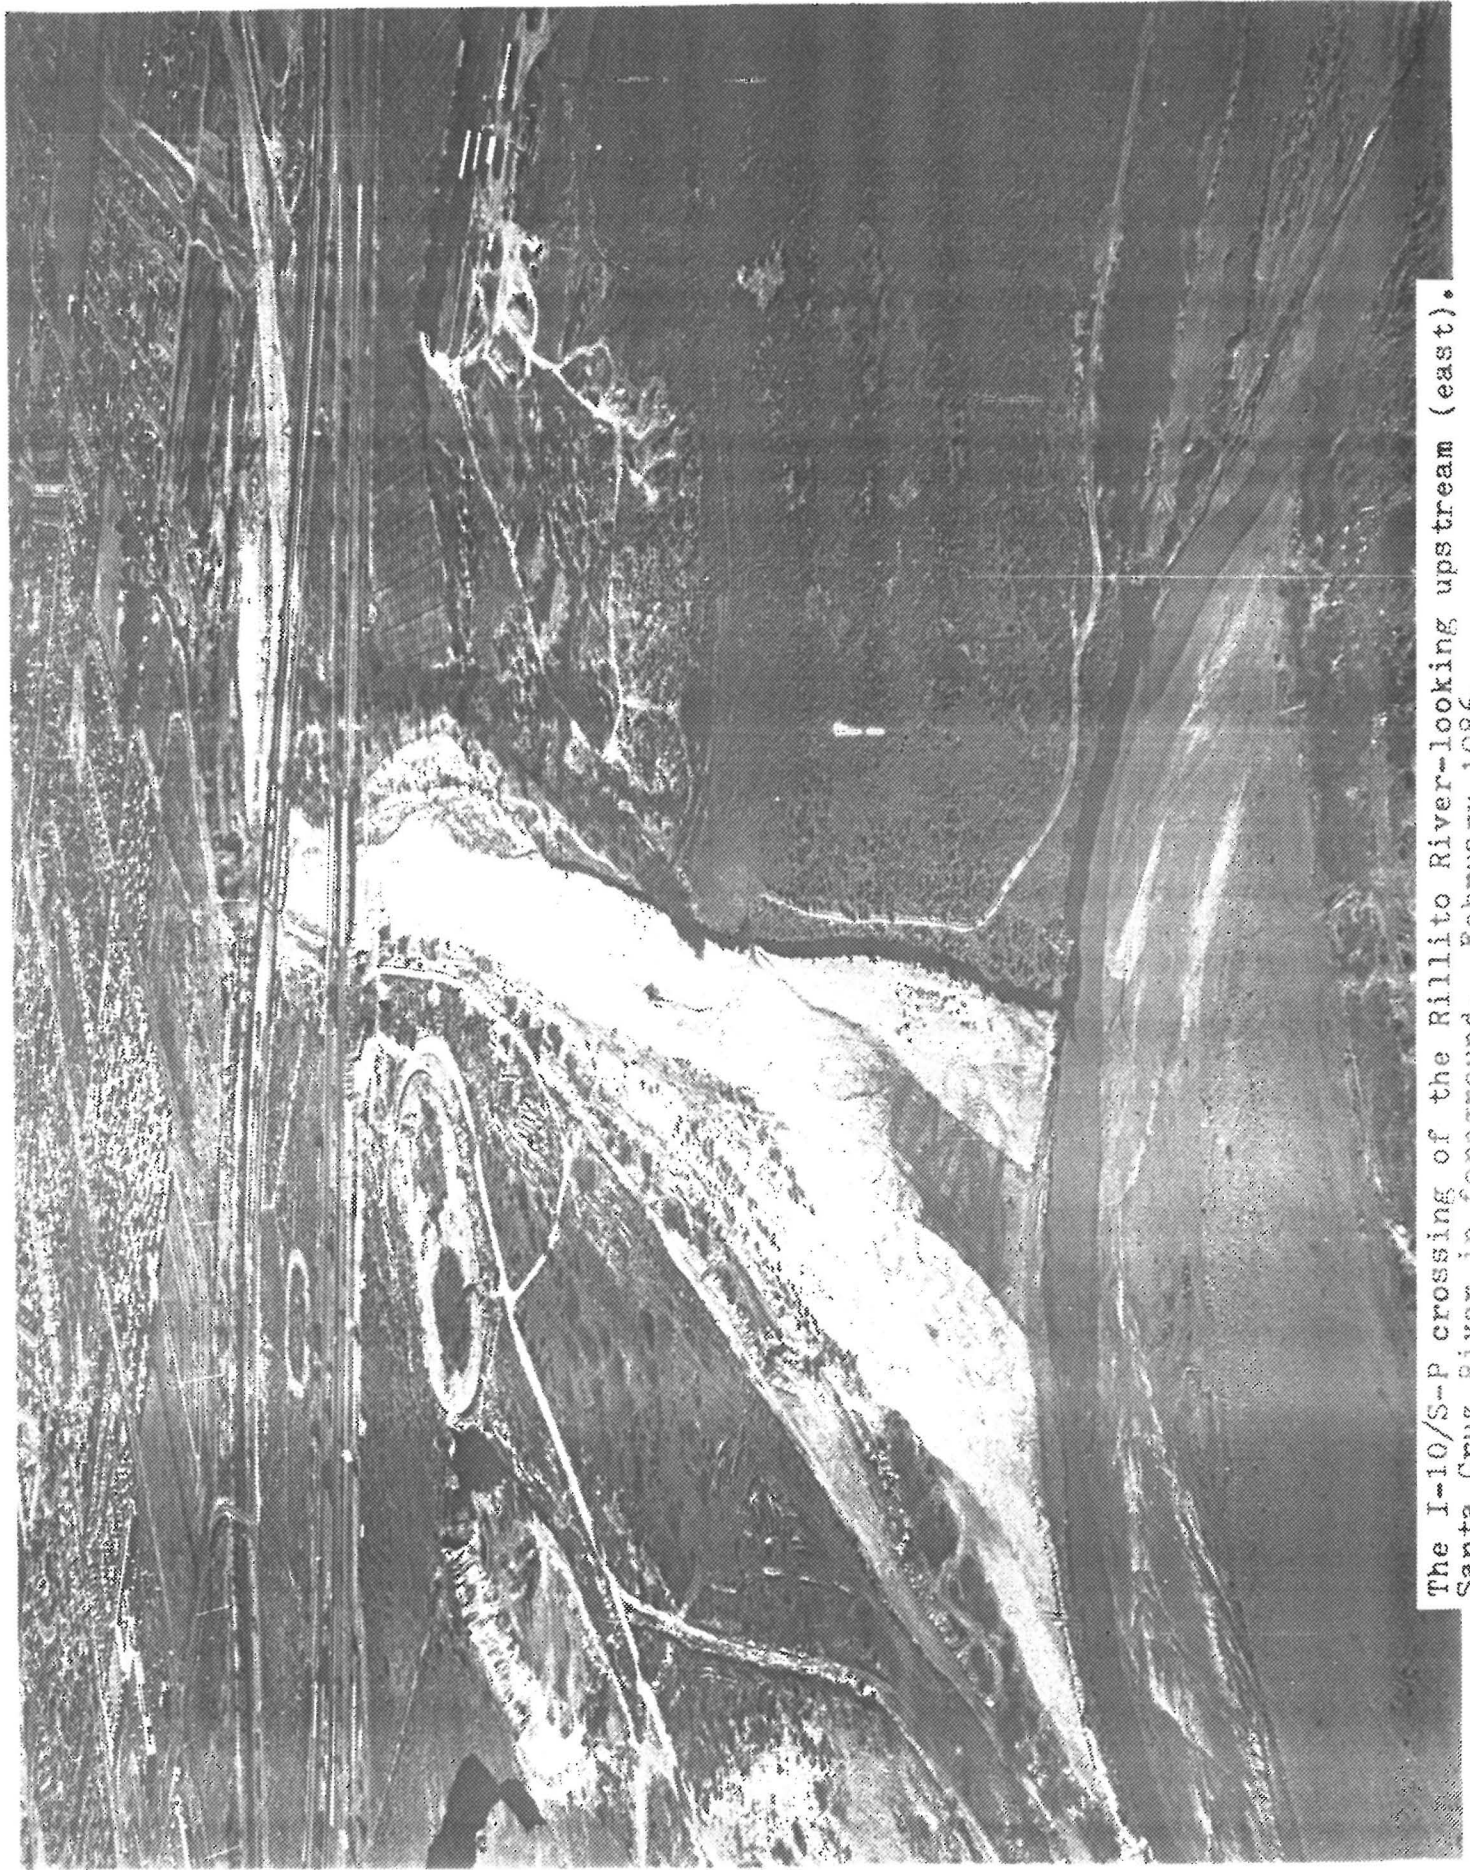
The I-10/S-P crossing of the Rillito River-looking upstream (east).
Santa Cruz River in foreground. February 1986.

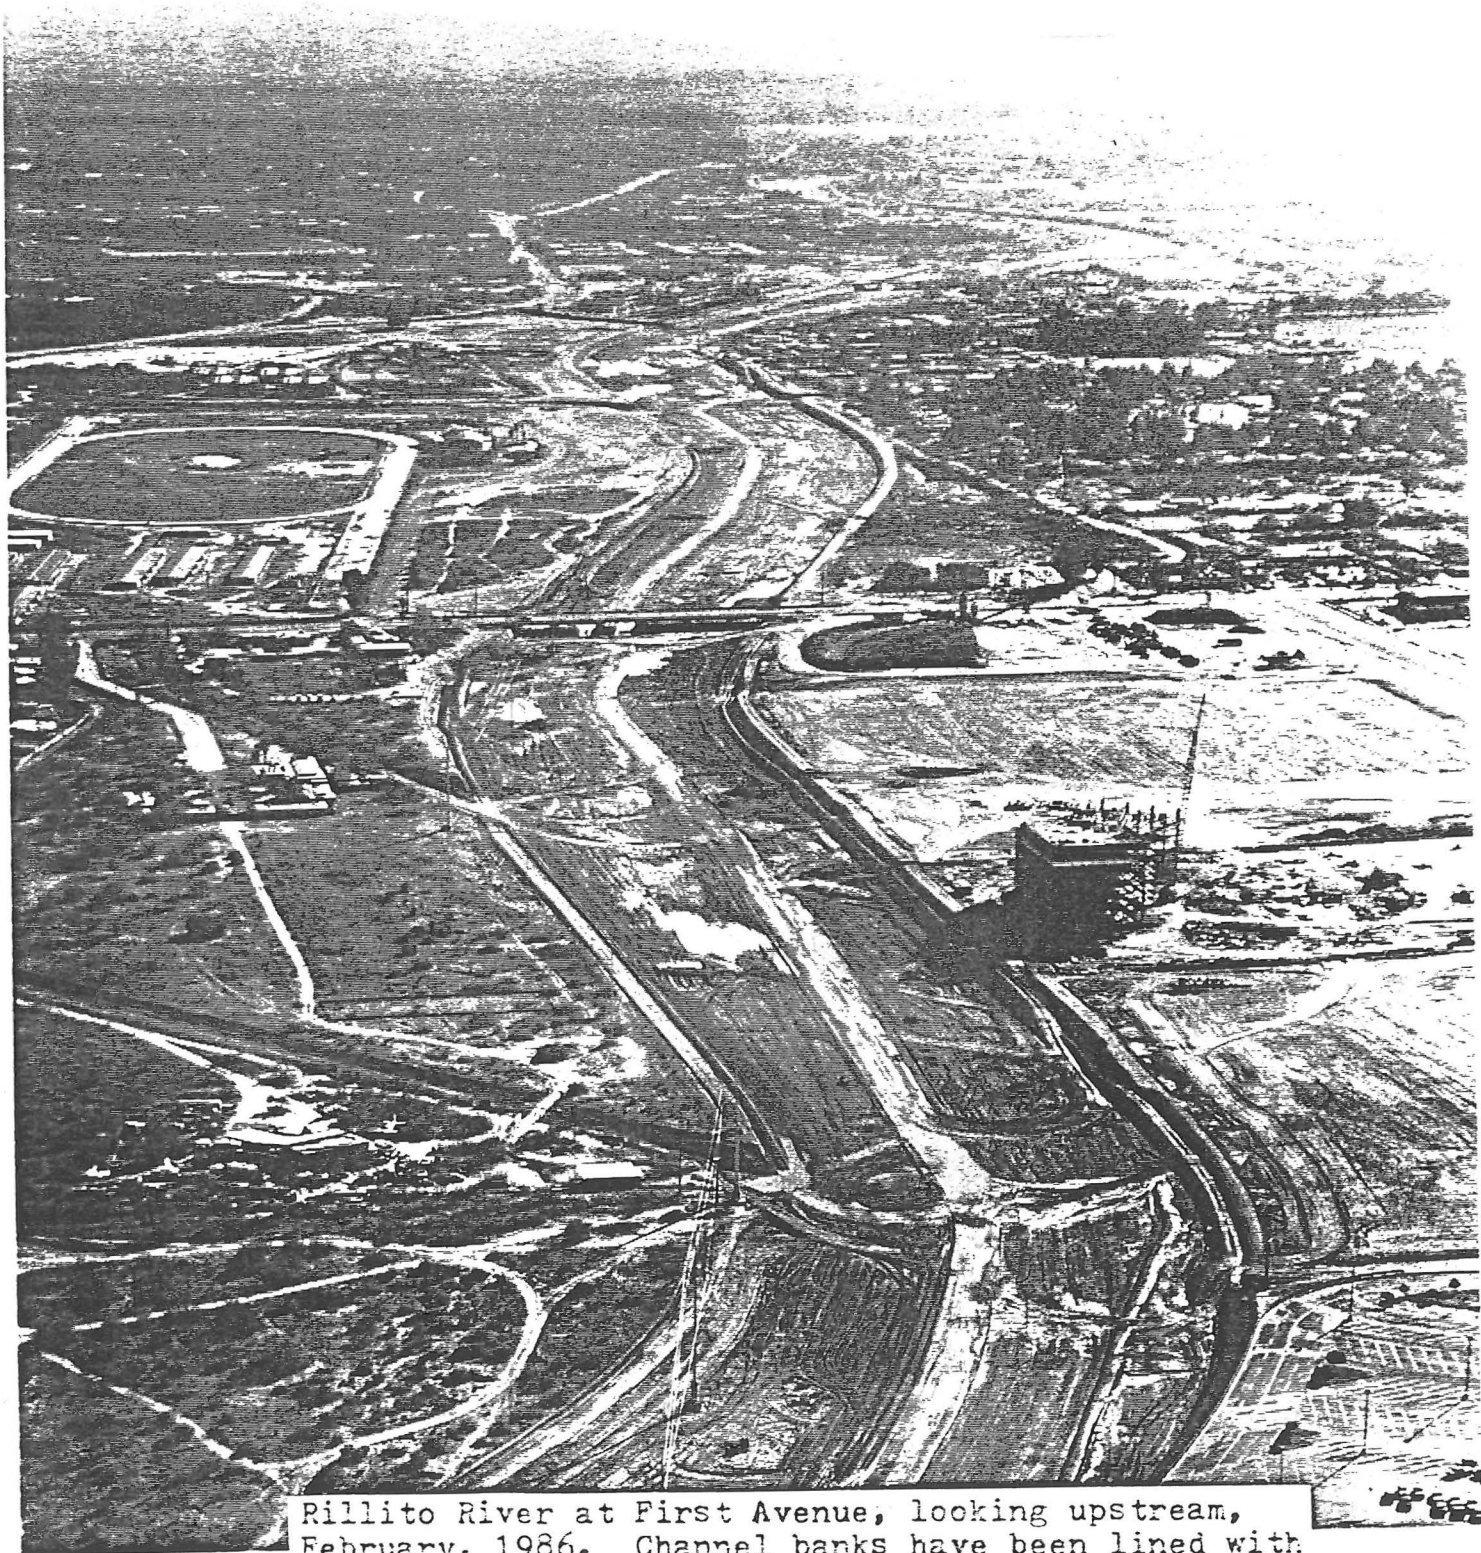
Rillito River at First Avenue, looking upstream, February, 1986. Channel banks have been lined with soil cement.

This portion of Rillito Creek has frequently experienced severe channel bank erosion during flow events of widely varying magnitude. Because of the existing alignment of the river at this location, flow impinges on the southern bank of the channel where it is deflected to the northern bank. At least twice in recent history, in December, 1965 and October, 1983, this erosional pattern occurred, resulting in the loss of and emergency repair of the northern abutment of the First Avenue bridge. In October, 1983, severe erosion of the bridge resulted in complete undermining and destruction of a newly constructed office building. The banks of this reach of Rillito Creek have since been stabilized with soil cement.
